## **Appendix K.**

**Photographs of Study Sites on the Illinois Waterway (Photographs of the Mississippi River Sites are on file with the Rock Island District, U.S. Army Corps of Engineers)**

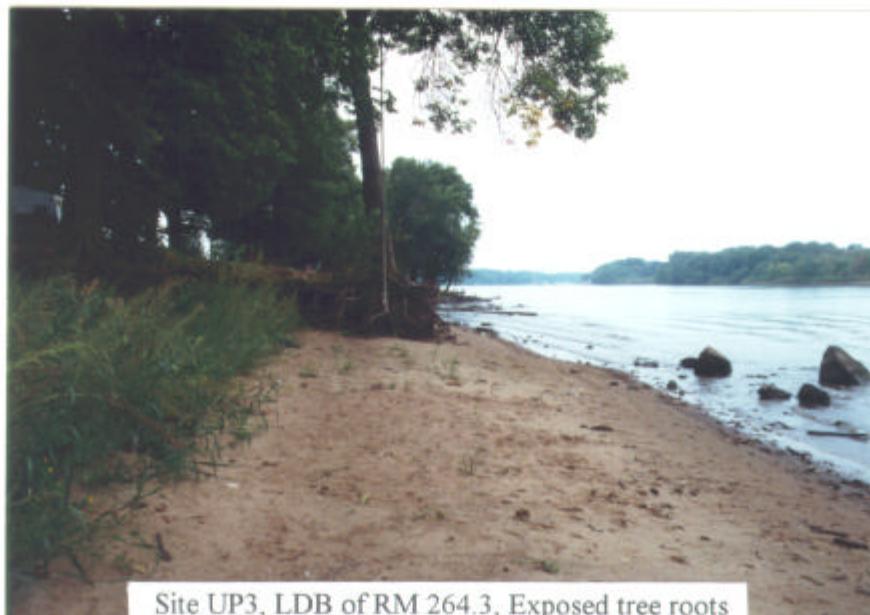
Site UP3, LDB of RM 264.3, Exposed tree roots

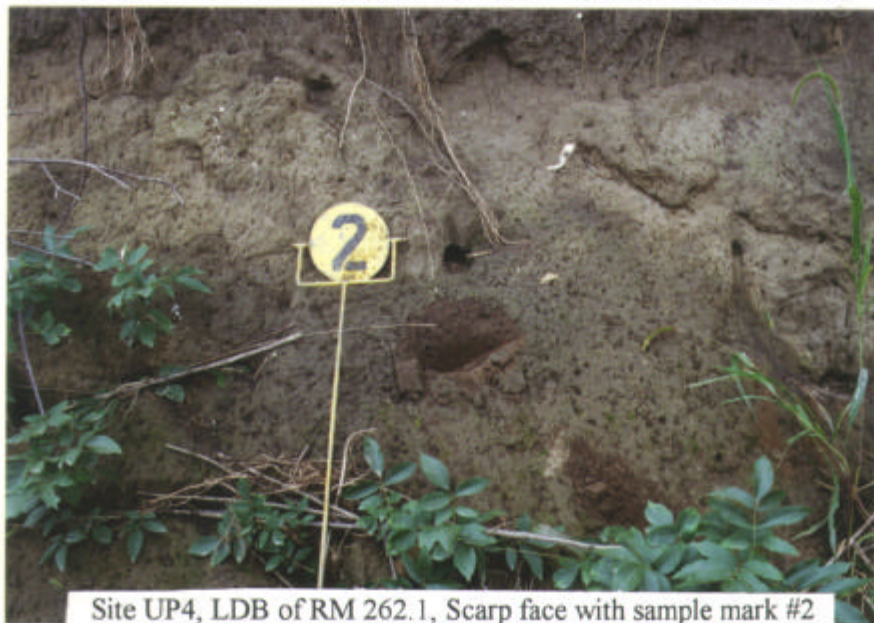
Site UP4, LDB of RM 262.1, Scarp face with sample mark #2

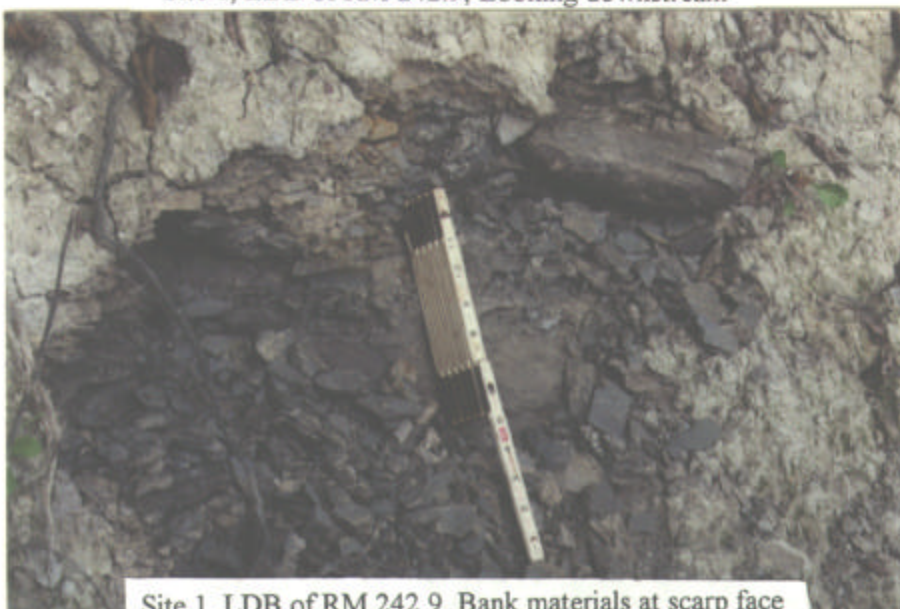
Site 1. LDB of RM 242.9. Bank materials at scarp face

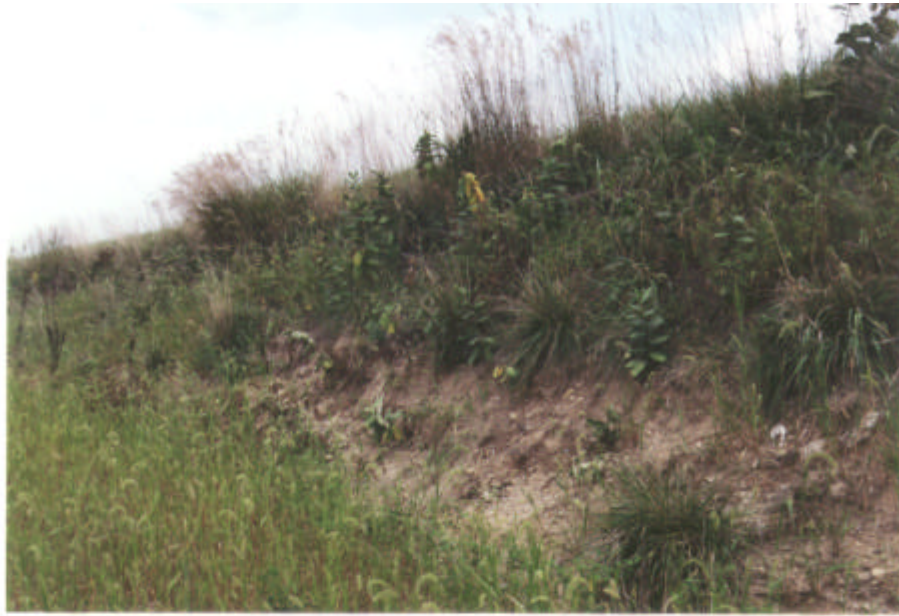
Site 7, LDB of RM 203.8, Scarp face at upper portion of the bank

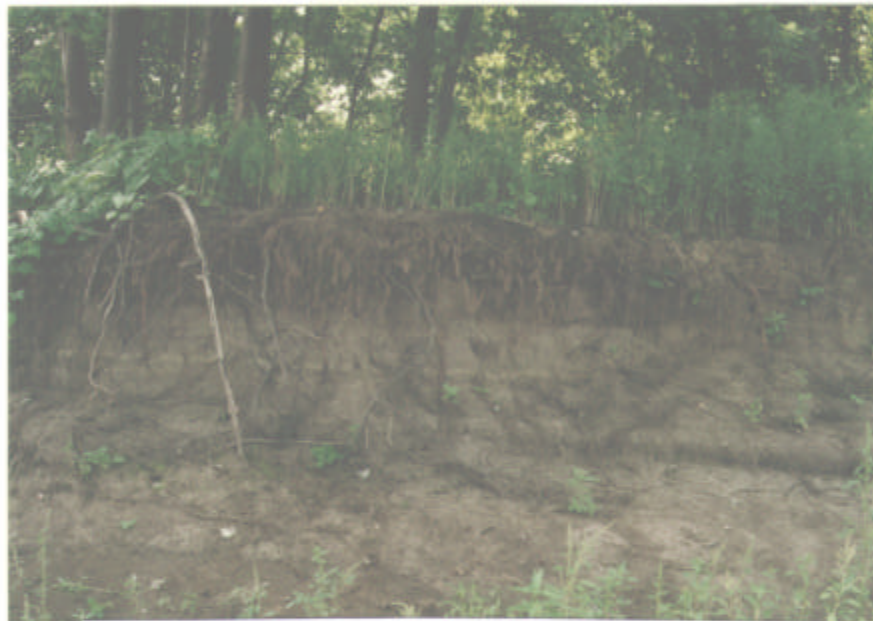
Site 16, LDB of RM 109.5, Scarp face at 100' upstream

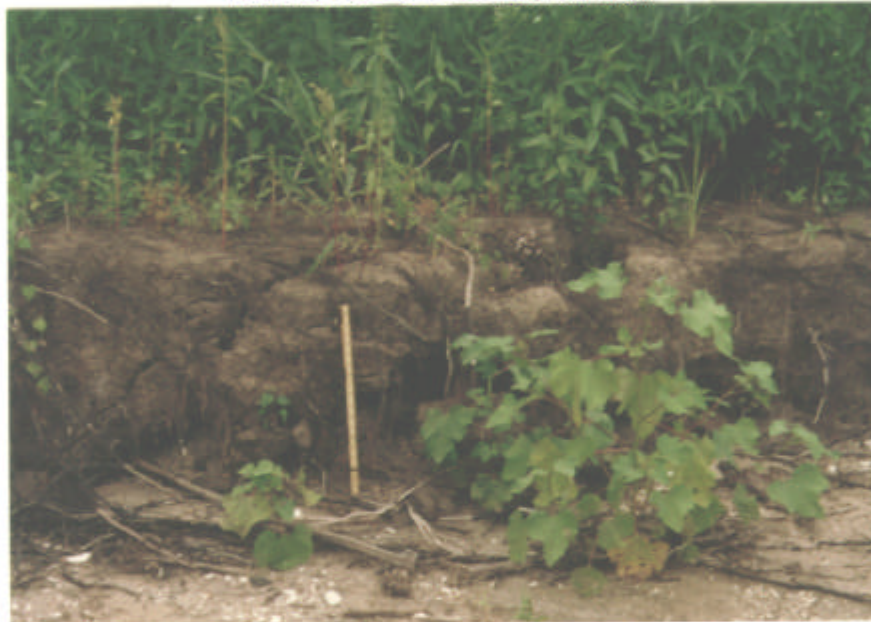
Site 18, RDB of RM 94.3, Mass collapsed on site

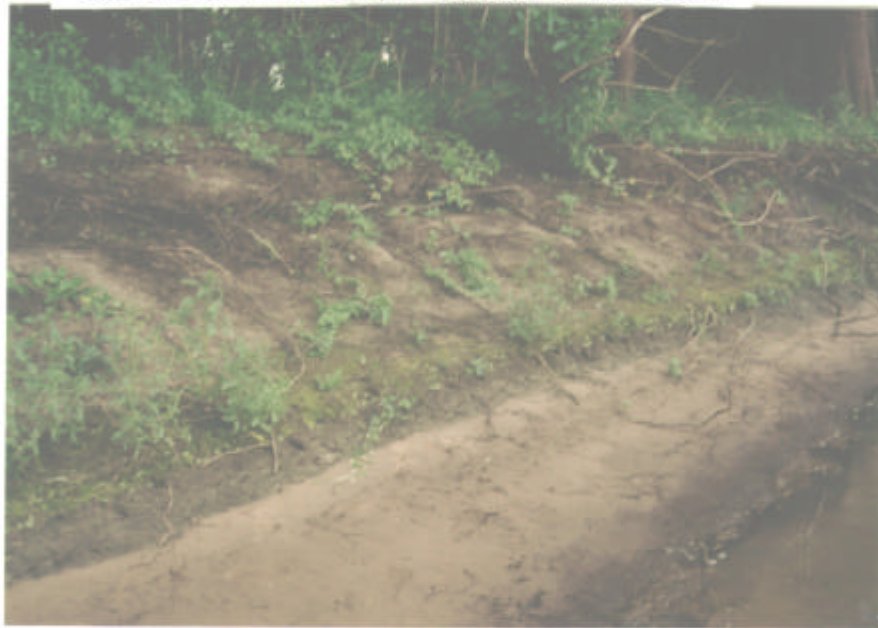
Site 19, RDB of RM 91.2, A closer view of bank conditions
